December 1, 2007

HOME INSPECTION REPORT

**Loft Building
Jersey City, NJ**

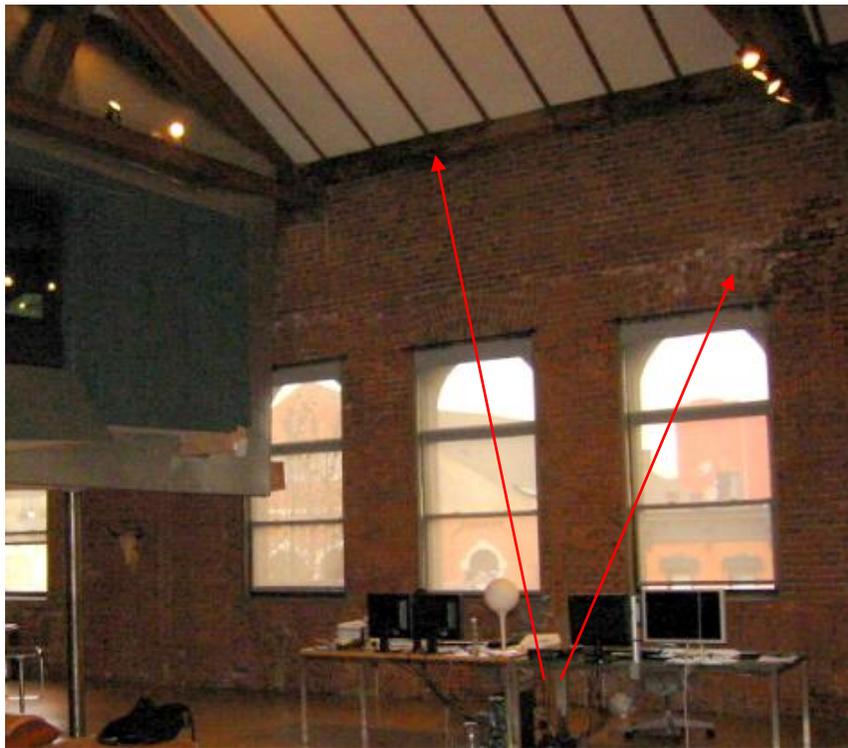
old red brick masonry, which are also the structural exterior walls of the building. The uppermost sections of the exterior brick façade shows recent re-pointing or replacement of the brick, however the major sections of the façade, including the area directly outside the unit do not show evidence of recent restoration. **Old red brick masonry exterior walls are by their nature porous, and therefore water penetration through these walls is possible, and when this occurs, damage to interior finish materials may occur.** The unit is at the front of the building and the front interior wall is the raw brick interior surface of the building structural wall. **Inspection of the interior surface of this wall did find evidence of water penetration in the form of white efflorescence stains in limited areas, as well as stains on the wood beam at the top of the wall.** The water penetration may be a result of inadequate water proofing of the exterior brick walls, or a roof leak, or a combination of both.

View of Interior of Front Wall- Stains suggest Water Penetration

Recommendation: Advise the building management of the evidence of water penetration of the brick wall, as they may have additional information regarding this condition, or may have a program or plan for repair. Monitor the wall for evidence of significant additional water penetration, and if this occurs, notify the building management immediately so that repairs can be done.

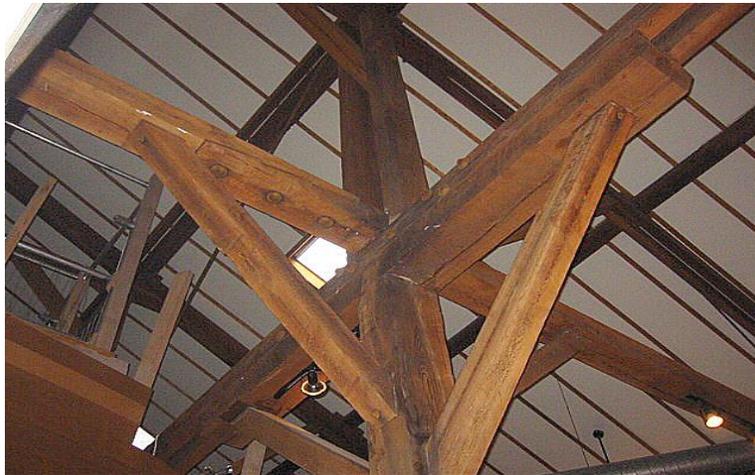
Typical Structural Framing Detail

No evidence of structurally significant defects was seen within the residence.

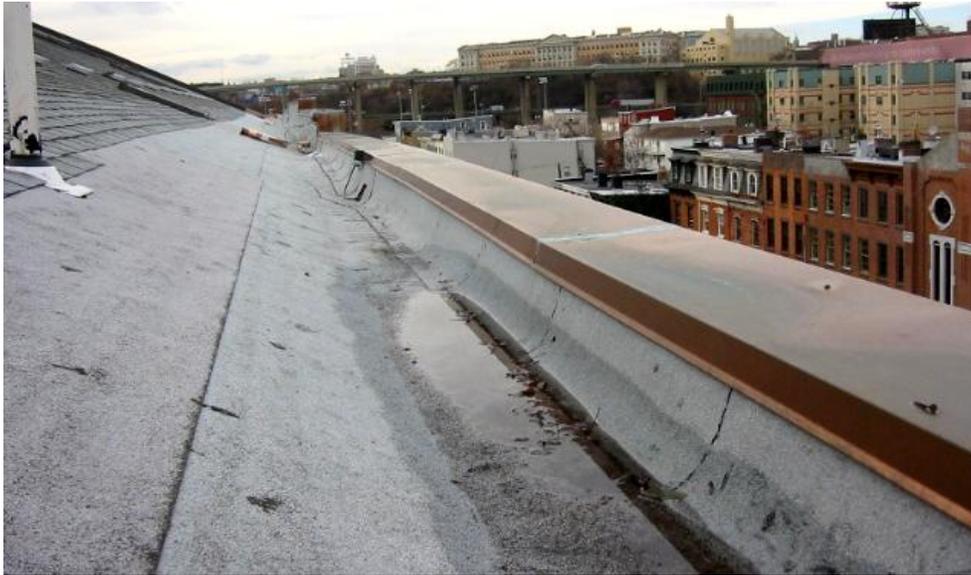
Roof Drainage System The roof is drained by a flat area at the roof edge with scuppers penetrating the parapet wall discharging to metal downpipes attached to the exterior of the building. The roof drainage system is a common element of the building, and only a limited area was directly inspected from the roof. **We observed standing water on the roof by the edge which indicates imperfect drainage.**

Standing Water at Roof Edge

- **Advise the building management of the adverse condition (standing water at the roof edge) so that they can take appropriate action.**

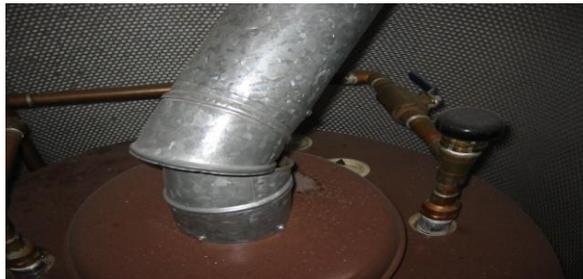
Water Heater Vent is Not Connected

The flue pipe venting this water heater had come loose, and this is a hazard.

- **Properly re-attach the water heater to the vent pipe.**

- **Properly connect the flue vent pipe to the water heater.**
- **Budget for near term replacement of this aging water heater.**

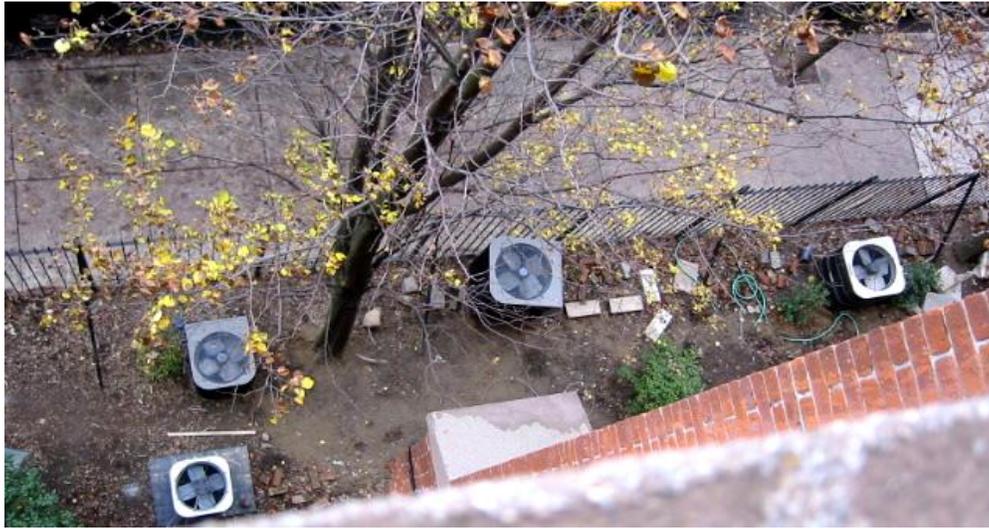
Exterior AC Equipment

Central Air Conditioning There is a central AC system, with air handler integrated into the furnace, and external compressor. The AC components located outside of The residence could not be inspected due to lack of access and the specific compressor/condenser unit for The residence could not be identified. Typical exterior central AC compressor lifetimes are 12 to 15 years, however failure before this time is not uncommon for this type of equipment. The AC system was not tested on the date of inspection, as the outside air temperature was too low for a safe and effective test.

- *Have the AC system serviced annually by a qualified technician.*
- *Inquire with the local utility about a “worry free” service contract for the central AC system.*
