HOME INSPECTION REPORT

Address Removed

Livingston, NJ

The following are the findings of a **Home Inspection** of the subject property done on July 16, 2008. This report is for the use of Client Name removed.

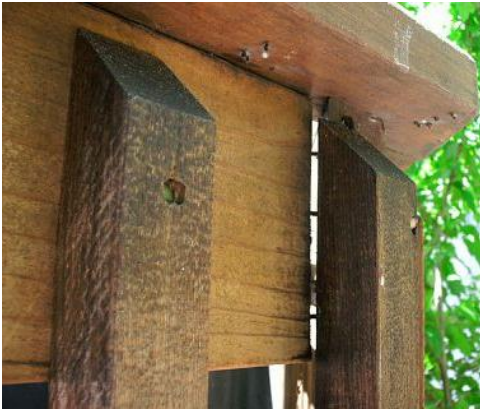
- **Some wear and separation between railing connections is present.**
- **The deck stair railing has been damaged by carpenter bee activity.**

Separation in deck railing

- **Have a qualified contractor repair worn, separated and damaged sections of the deck railing.**

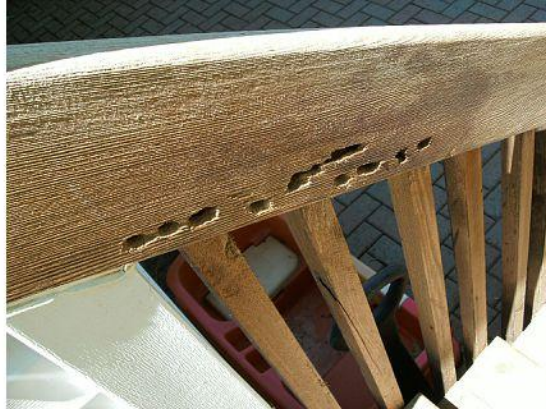
Carpenter bee damage

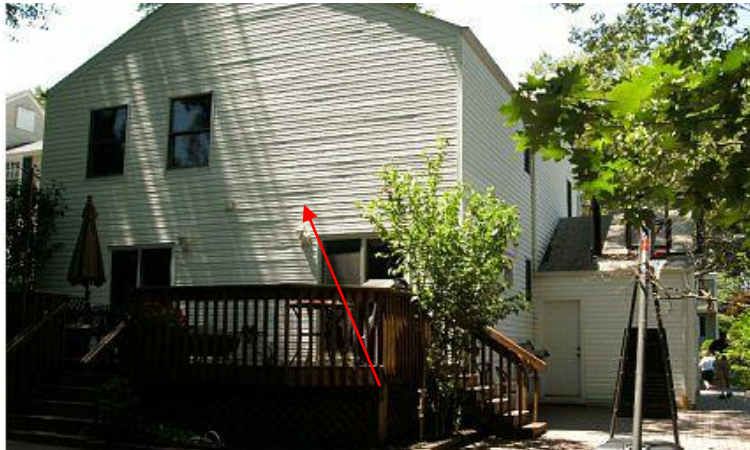
- **The vinyl siding on this home appears to have been applied over older siding material. The vinyl siding shows some irregularity, which at this time appears to be a cosmetic issue only, however the irregularity may be a result of inadequate installation, and siding may begin to loosen or fail in the future.**

Vinyl Siding Shows Irregular Surface

Monitor the vinyl siding for further evidence of defects or looseness. Repairs may be needed if further defects occur. You may wish to have this siding installation further evaluated by a specialist to determine if hidden installation defects of significance are present and need correction.

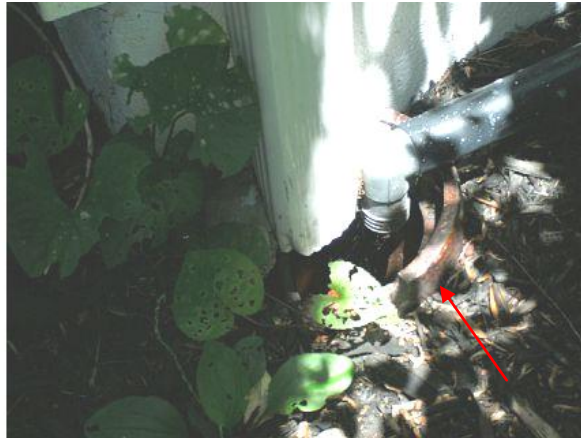
- **Some downspouts discharge too close to the base of the home.**
- **Some downspouts discharge into older underground clay pipe. This older pipe is likely clogged and/or broken below ground.**

Old underground clay pipe

- **Direct all above ground downspout discharge points as far away and downhill from the base of the home as is practical.**
- **Older underground clay pipe is likely clogged. Have this pipe replaced, or direct downspout discharge downhill and away from the home above ground.**
- **Have the roof drainage system cleaned and maintained on a regular basis by a qualified gutter maintenance company.**

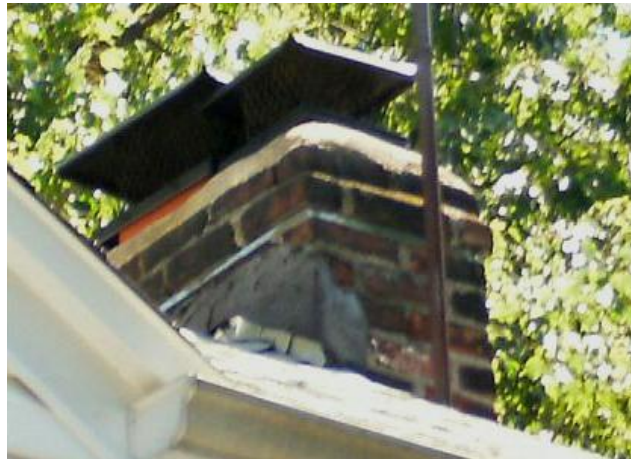
- **Chimney flashings appear to be older, with some newer flashings applied over old flashings. Leakage can occur around older chimney flashings.>**
- **Some cracks, loose and missing sections of mortar were seen on the upper sections of the chimney.**

Masonry Chimney needs Service

- **The National Fire Protection Association and the National Chimney Sweep Guild recommend that, due to the advanced age or other conditions, a Level-2 Inspection of the chimney and internal components be done to rule out hidden potential safety defects.**
- **Have a qualified chimney contractor service or repair the chimney(s) as required to assure long term function and safety.**

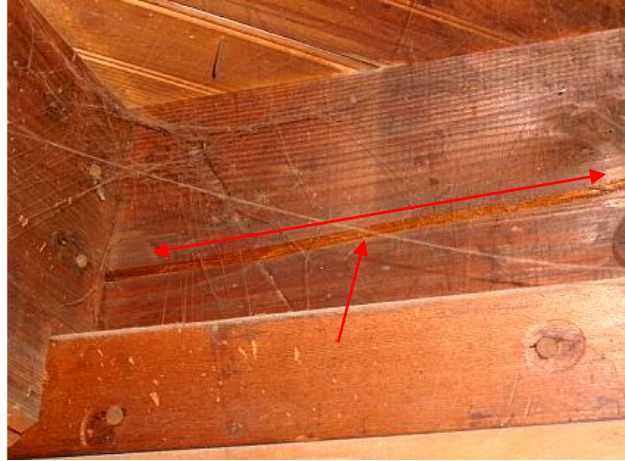
- The main beam has a significant shrinkage crack visible for part of its length. *Most sections of the main beam were not visible, hence we could not fully evaluate the defect in the beam.*

Cracked section of main beam

- **Have a qualified contractor familiar with structural reinforcement further evaluate structural floor framing, including joist connection points to the main beam, and the extent of main beam cracking, and make repairs and reinforcements as necessary. Such evaluation will require removal of some portions of the basement finish ceiling.**

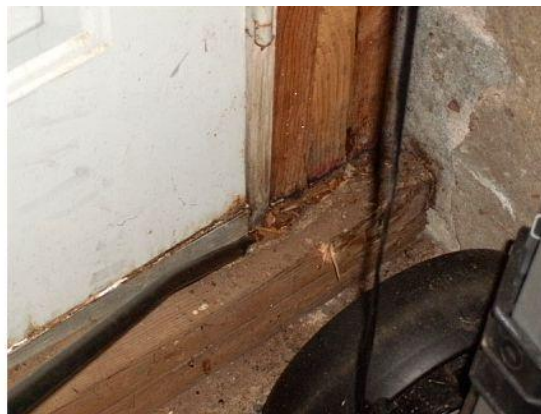
Carpenter ant damage section of the sill plate

Garage Structure: **The sill plate near the door to the house has been damaged by wood destroying insect activity.**

- **Have a qualified contractor familiar with wood destroying insect damage repair further evaluate and repair any areas of wood destroying insect damage. See the separate wood destroying insect report from Terminite, Inc. for more information relating to the wood framing of this home. If evidence of wood destroying insect infestation is found, then be aware that further evaluation would be required to assure that hidden damage to structural members is not present.**

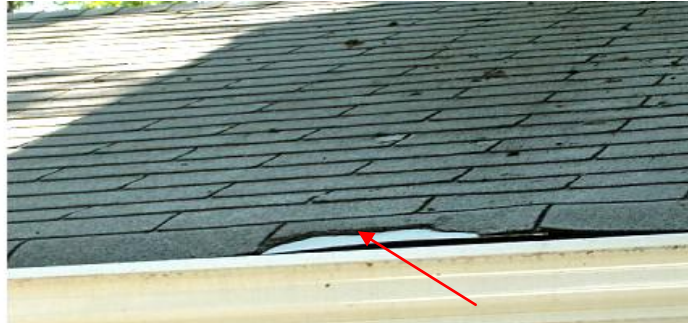
- **Roof shingles appeared to have significant wear.**
- **Some roof flashings may be older than the currently installed roof. Leakage can occur around old flashings.**

The Roof is Worn – example of broken shingle shown here

- **Have a qualified roofer periodically evaluate the roof for wear and/or leakage, and make repairs or replacements as necessary.**
- **Have a qualified roofer add more ventilation to the roof.**

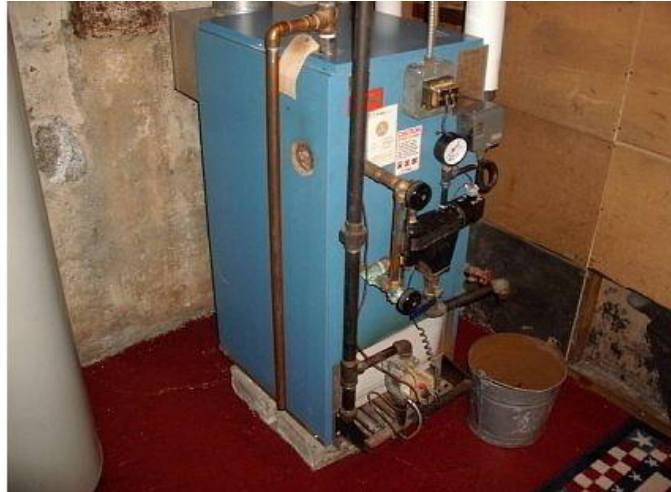
Older Steam Boiler

- **The heating components are nearing the end of their designed service life, and the probability of hidden internal defects that can affect function and safety is increased.**
- **Radiators and steam or circulated water pipes are older, and maintenance and repair to these older components should be anticipated.**

- **Further evaluation by a qualified specialist to assure that hidden defects or safety related issues are not present.**
- **Budget for the need for replacement of the boiler in the near future.**
- **Monitor radiators and radiator connections for leakage, and have any leaks repaired promptly.**
- **A service contract to cover future maintenance and repairs to the heating system.**

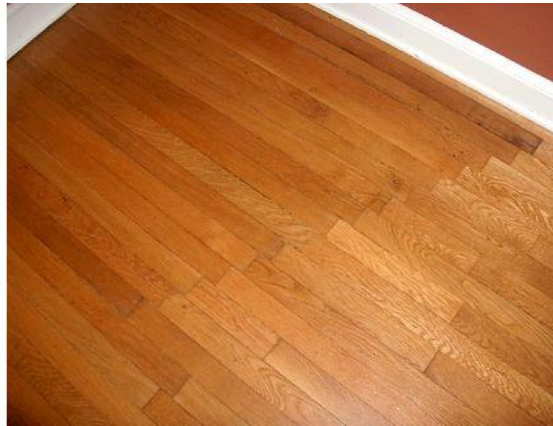
- Generally functional – normal wear and/or minor defects.
- *A section of wood flooring on the first floor appears to have been poorly installed or replaced. The flooring strips have not been well integrated together, and form an unsightly jagged pattern. This is a cosmetic issue that does not appear to affect functionality.*

Jagged flooring pattern
