August 14, 2008

HOME INSPECTION REPORT
Street Address Removed for Privacy
Warren, NJ

Street Address Removed, Warren, NJ

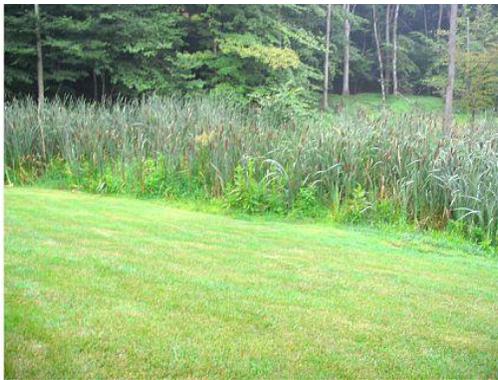
- **A low area is present at the rear of the property has wetland type plants. This may be an area of water accumulation.**

Wetland plants at the rear

- **Additional drainage may be required at the left rear of the driveway.**
- **Monitor the property for areas of water accumulation over time, and have additional drainage installed as necessary.**

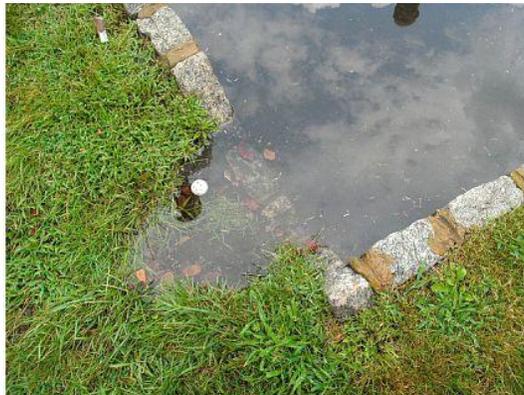
- **Water accumulation was occurring at the left rear of the driveway.**

Water at driveway left rear

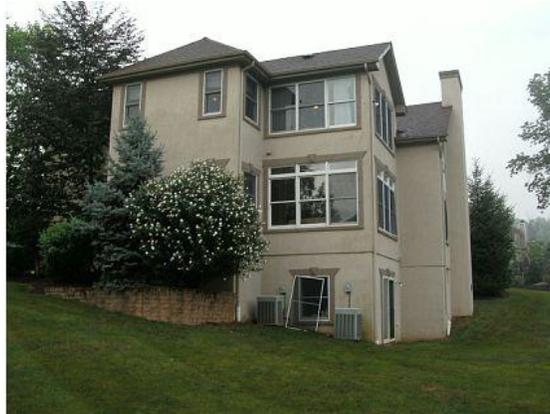
- **Overgrown vegetation in close to or in contact with the sides of the house.**
- **Trees or tree branches adversely impacting the home.**

Trees and shrubs in contact with the home

- **Have trees, shrubs and plants trimmed back or removed as necessary so they are no longer in contact with the home.**
- **Have the retaining wall at the right side adequately rebuilt by a qualified contractor.**

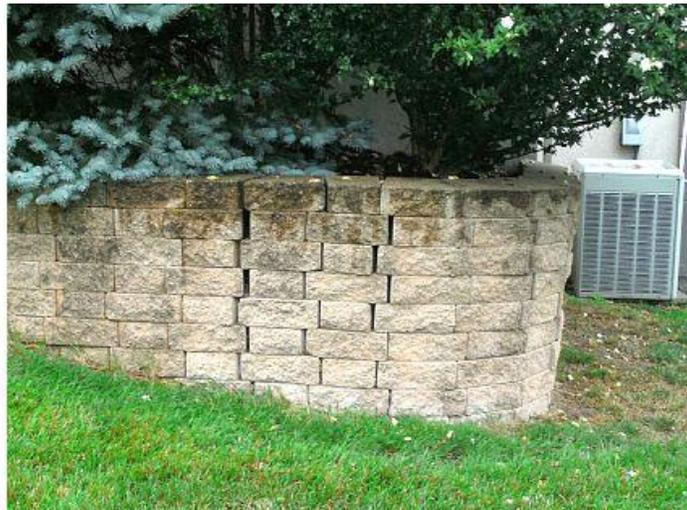
- **A retaining wall at the right side around plants and trees is failing. It is unknown if this retaining wall plays a role in support of the house itself. If so, failure of this retaining wall may adversely affect the structure of the home.**

Failing retaining wall

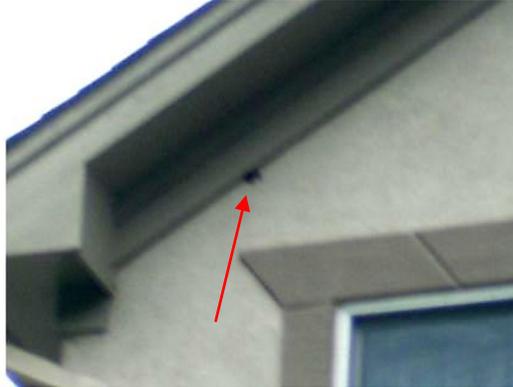
- **Holes in the EIFS siding and trim are present in several areas, including along the top of the chimney surround, on the right side, and in one area on the rear. These holes may have been caused by golf balls. Golf tees were found in the back yard, and several of the holes are sized to suggest golf ball impact. EIFS is a fragile material, and impacts from an object of any significant weight and velocity will cause damage.**

Hole in EIFS siding

- **Water entry may occur into the damaged areas of EIFS siding, which can result in water damage to wood sheathing and could cause mold growth.**
- **Green staining is present on the right side and by the front entry area. This may be due in part to excessive vegetation in these areas or other high moisture conditions.**
- **There are siding details where the EIFS material is in contact with horizontal masonry shelf details, flashing and provision for water diversion is questionable, and this critical areas may allow water entry behind and damage to the structure of the home if not properly designed and installed.**

- **Further expert specialist evaluation of the EIFS façade is needed to determine true condition and recommend repair or re-work as may be needed to assure long term functionality. Since improperly installed or maintained EIFS facades have caused very costly damage to homes, you are strongly urged to have this specialist evaluation performed before you close on this property. Repairs of unsatisfactory or damaged areas of EIFS should be done only by a qualified siding contractor familiar with this material and proper installation technique.**
- **See Landscaping section – have excessive vegetation removed.**

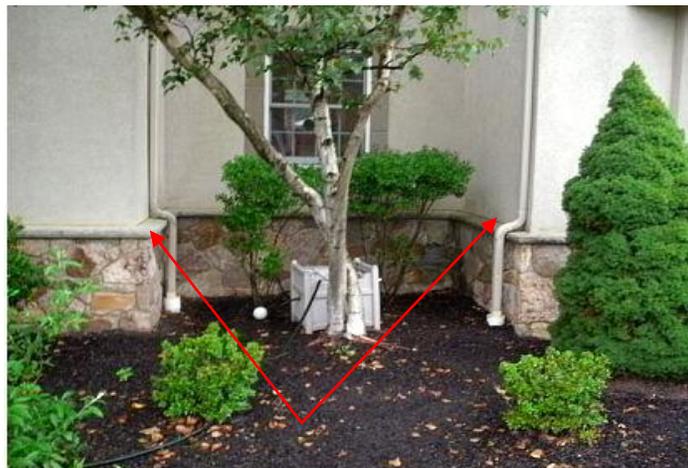
Interface of EIFS and Masonry Shelf may be one of several areas where water may enter behind the façade

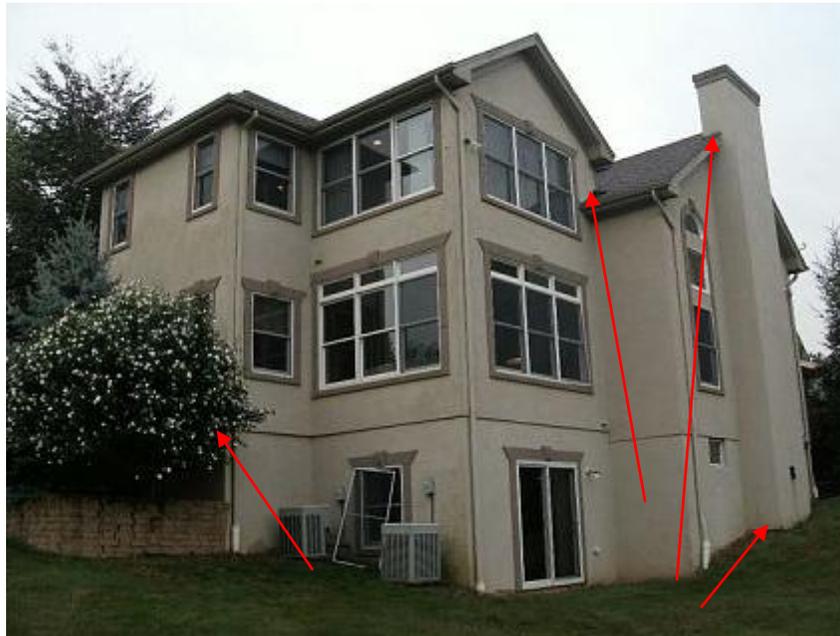
Other areas where EIFS may be damaged by water intrusion unless proper flashing and detail is followed

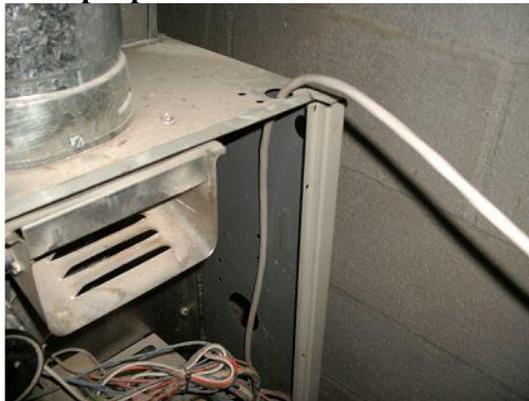
- **The electronic air cleaner did not appear to be functional on the date of inspection.**
- **There is a small cable / wire connected to wiring inside the furnace that is poorly secured. The purpose of this cable could not be determined.**

Loose cable entering the furnace

- **Further evaluation by a qualified specialist to determine the purpose of the loose cable, and either remove it if not necessary or properly secure the cable.**
- **A service contract to cover future maintenance and repairs to the heating system.**

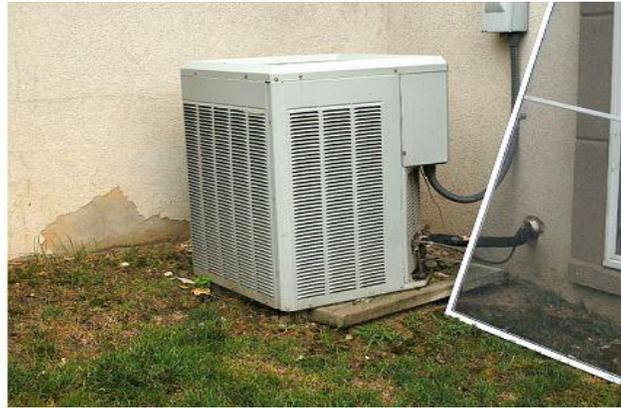
- **One of the AC compressors has shifted position, and is no longer fully on its pad. Further shifting could result in damage.**

AC Unit Shifted off Pad

- **Have an AC technician re-set the compressor firmly on its pad, and ensure that no damage has occurred to the compressor or coolant tubes.**
- **Have the AC systems serviced annually by an AC technician.**

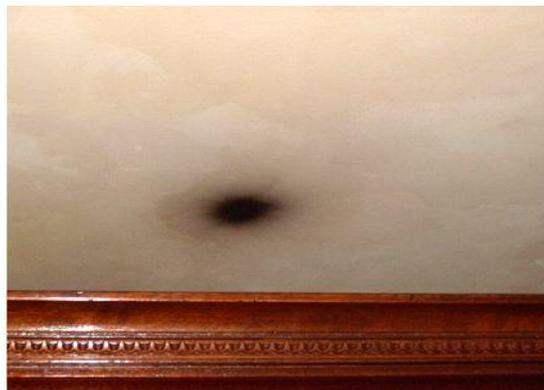
Wall and Ceiling Condition: Generally functional – only minor repairable defects. **A black spot is present on the ceiling in the master bedroom, approximately 3 inches in diameter. This appears to be a scorch mark, possibly from a candle set on top of an armoire, however this could not be determined with certainty.** The area around this mark was tested with a moisture meter, and was found to be dry.

Mark on ceiling

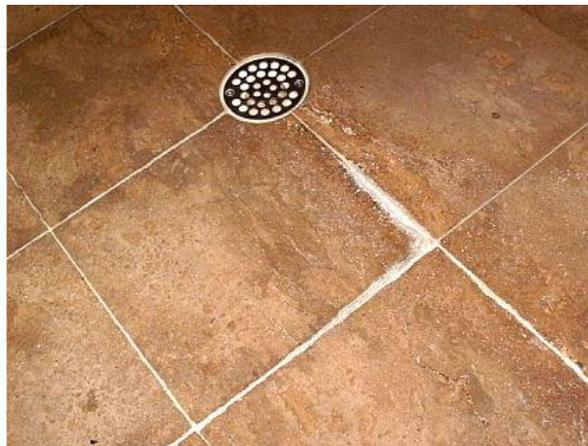
- **The toilet in the first floor full bathroom is loose.**
- **The tub / shower faucet handle in the second floor main bathroom has come off.**
- **The shower floor in the master bathroom has a buildup of minerals at tile junctions, and may not be adequately sloped towards the drain. This mineral build-up may be an indication of a defective shower base which could result in leakage through the tile base.**

Buildup around tile

- **Have a plumber repair the loose toilet in the first floor full bath.**
- **Have a plumber repair the tub / shower faucet handle in the second floor main bathroom.**
- **Have a qualified tile contractor and/or plumber further evaluate the master bathroom tile shower floor and cracked door sill, and make repairs as necessary to ensure a long term leak free condition. The shower base may have to be re-tiled.**

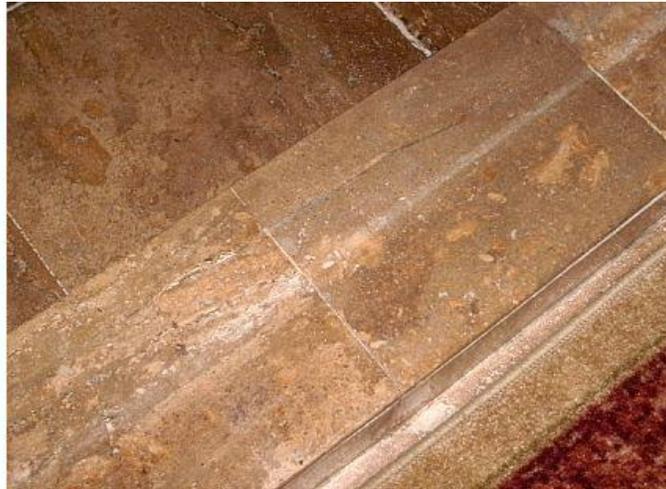
- **The master bathroom shower door sill is cracked.**

Cracked door sill

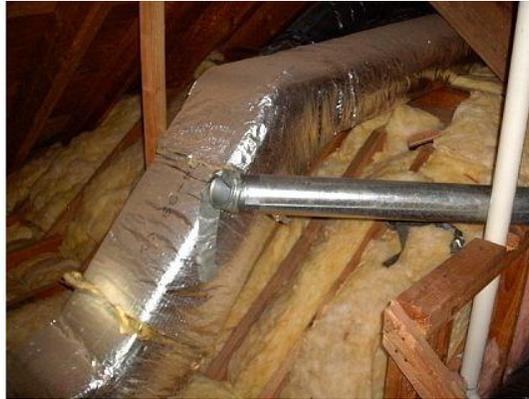
- Ventilation of the space under the roof appears to be adequate.
- **It appears that a bathroom vent fan discharges into the center of the attic space. This can cause moisture buildup and possible mold growth.**

Bath vent fan discharging into center of attic space

- **Have a contractor extend the bathroom vent fan ducting to be close to one of the vents in the roof, so that most moisture will exit through the vents.**

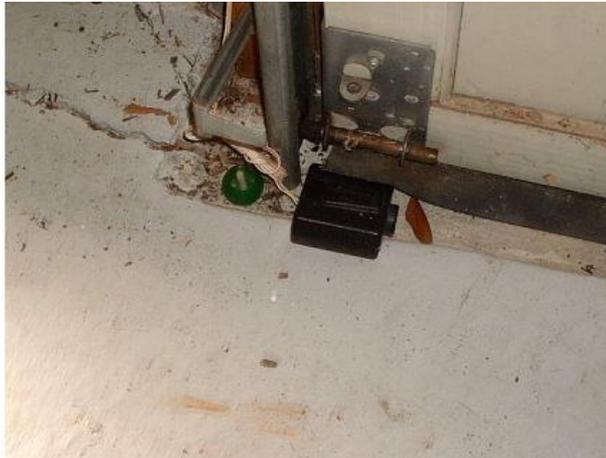
- **The left side door was not operational, and the power opener safety cutoff sensors had come loose. The sensors were lying on the garage floor.**

Sensor on floor for left side garage door

- **Have a qualified garage door contractor repair the left side door and door opener sensors and hardware as necessary, re-installing sensors at an appropriate height (6 inches from the floor or less) and ensuring that the door operates safely and reliably.**
